**DEPARTMENT OF TRANSPORTATION**

Contract #: 04-0120F4Cty: SF/ALA Rte: 80 PM: 13.2/13.9File #: 69.28**WELDING INSPECTION REPORT****Resident Engineer:**Siegenthaler, Peter**Address:** 333 Burma Road**City:** Oakland, CA 94607**Report No:** WIR-018063**Date Inspected:** 28-Oct-2010**Project Name:** SAS Superstructure**OSM Arrival Time:** 700**Prime Contractor:** American Bridge/Fluor Enterprises, a JV**OSM Departure Time:** 1900**Contractor:** Zhenhua Port Machinery Company, Ltd (ZPMC), Changxing Island **Location:** Shanghai, China**CWI Name:** Xu Xian Ping**CWI Present:** Yes No**Inspected CWI report:** Yes No N/A**Rod Oven in Use:** Yes No N/A**Electrode to specification:** Yes No N/A**Weld Procedures Followed:** Yes No N/A**Qualified Welders:** Yes No N/A**Verified Joint Fit-up:** Yes No N/A**Approved Drawings:** Yes No N/A**Approved WPS:** Yes No N/A**Delayed / Cancelled:** Yes No N/A**Bridge No:** 34-0006**Component:** Orthotropic Box Girder (OBG)**Summary of Items Observed:**

OBG # BAY 6

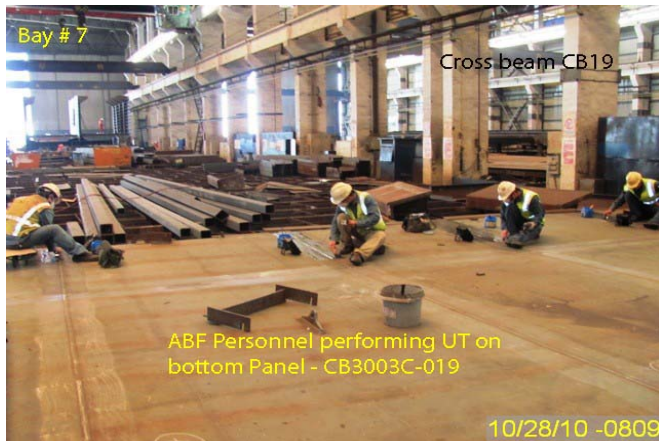
This QA inspector observed that ABF personnel perform Ultrasonic Testing (UT) on cross beam CB19 bottom panel splice weld. The bottom panel is identified as CB3003C-019. See attached pictures.
